# **Petition for the Reconsideration and Modification of the National Transportation Safety Board's Findings and Determination of the Probable Cause for the Crash of TWA Flight 800**

*The TWA 800 Project  
6/18/2013*

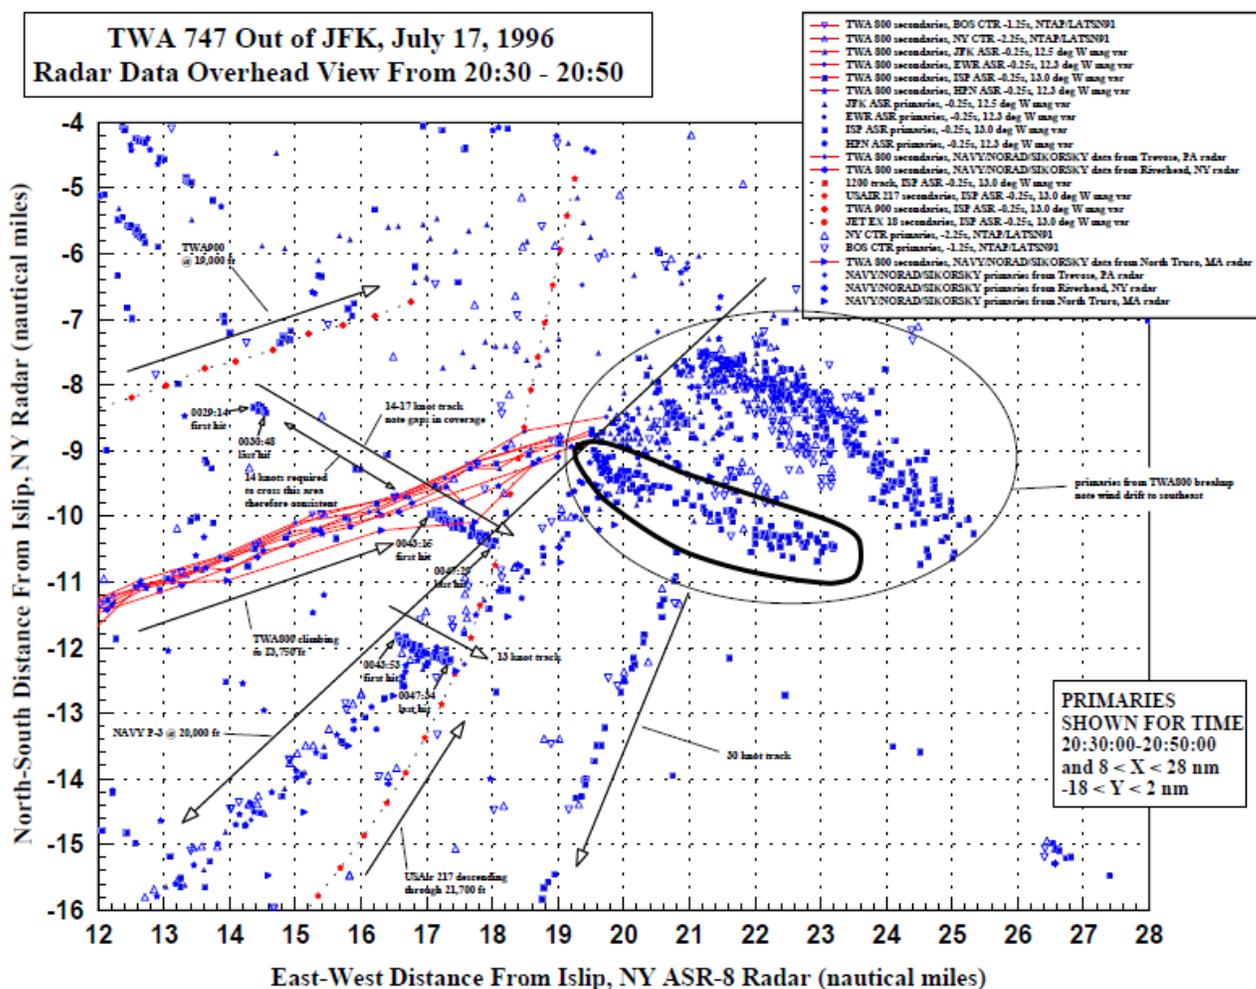
Within 8.5 seconds of TWA Flight 800 losing electrical power, a heavy concentration of light debris began appearing on the FAA radar between 1/3 and 1/2 mile due south of and almost perpendicular to TWA Flight 800's flight path. The majority of this debris stopped most of its horizontal motion and began falling to the ocean 1/2 mile south of where TWA Flight 800 lost electrical power. As it fell to the ocean, the wind carried this debris toward the SE for more than ten minutes. The Islip, White Plains, and JFK radar sites recorded the debris as it fell. When plotted over time, the radar returns from this debris appear as a distinctive, diagonal band, as shown on the NTSB radar plot below.

**Figure 1:** NTSB radar plot from page 44 of the Airplane Performance Study (Exhibit 13A). The band of debris in question has been circled by the petitioners with a thick black line.

At the 1997 NTSB hearing in Baltimore, NTSB investigator John Clark testified that the above-mentioned plume of radar returns (circled with a thick black line above) was “consistent with the explosion” that caused the crash. However, Mr. Clark did not provide a scientific basis for that conclusion nor did he attempt to further characterize that explosion by presenting an analysis of the subject radar returns. Our analysis of the speed and direction of the circled radar returns presented below demonstrates that the explosion responsible for the propagation of these returns was, in fact, a high velocity explosion--a detonation. The official NTSB theory for the crash is based on the assumption that the explosion in question was a low-velocity explosion or deflagration of fuel-air vapors and therefore cannot account for this radar-recorded detonation.

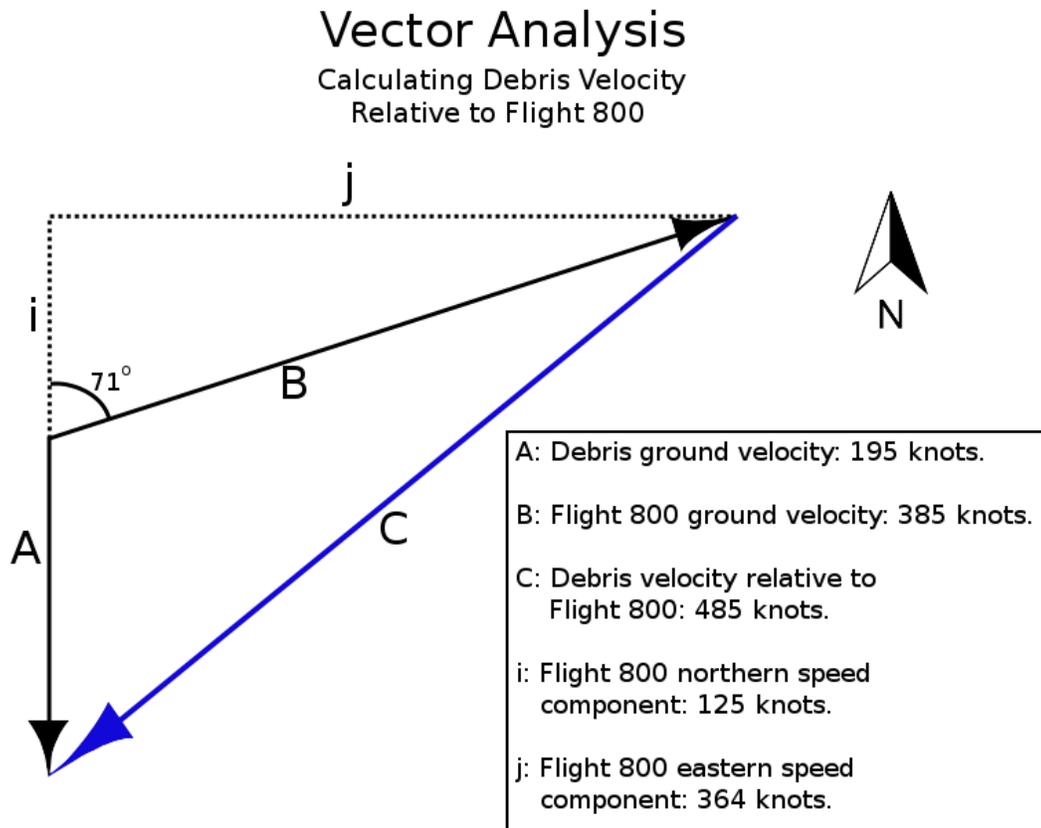
Using the Pythagorean Theorem, the average speed of the debris relative to the accident aircraft was between 463 and 495 knots or between 238 and 255 m/s.

**Figure 2:** Addition of Flight 800 and debris velocity vectors. The blue line labeled **C** represents the debris' velocity relative to Flight 800. Lines **A** and **B** represent the ground velocities of the debris and Flight 800 respectively. Lines **i** and **j** represent Flight 800's northern and eastern speed components.

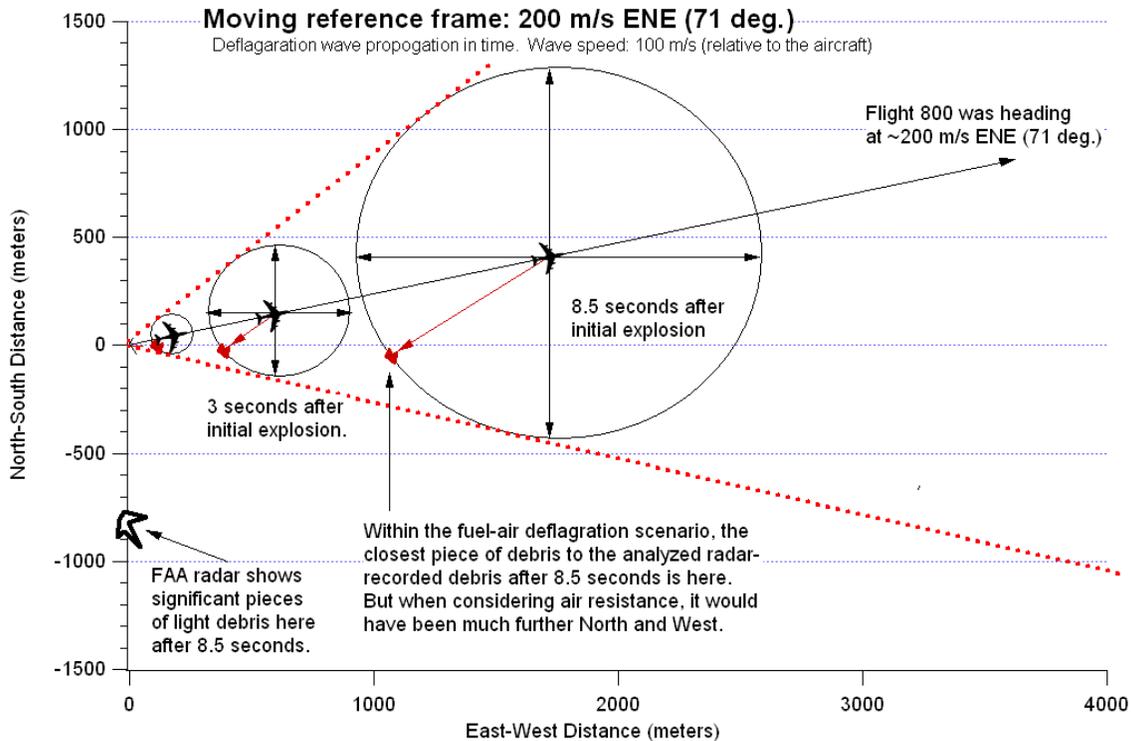
**Figure 3:** Maximum deflagration wave expansion at three points in time in TWA Flight 800's reference frame. Air resistance is neglected outside the aircraft to provide a best-case scenario for the NTSB's crash sequence. The red arrows point to hypothetical debris ejected by the deflagration. The 747 icons are not to scale.

In Figure 3, the circles represent the maximum expansion of the officially proposed fuel-air deflagration. The red dotted lines represent the maximum horizontal distance any piece of debris could have traveled in the first moments after the explosion. The hypothetical wreckage item colored red at the lower left edge of each circle represents the most dense and streamlined wreckage fragment, since the effects of air resistance would be lowest for such fragments. But as can be seen, even a fragment with those properties would still be more than one kilometer away from where radar sites recorded the debris plume at 8.5 seconds.

Since TWA Flight 800 was traveling about two times faster than the wave propagation speed of the proposed fuel-air deflagration, nothing from that deflagration could have reached the position where radar sites recorded the debris in question, which is represented by a large irregular shape on the left axis of Figure 3, about 800 meters south of the position of the initiation of the explosion. As discussed above in the *Error Analysis* section, the actual position of the debris detected on radar at 8.5 seconds could have been anywhere between approximately 1/3 and 1/2 of a nautical mile due south of the explosion, or between 700 and 1000 meters south of the explosion.

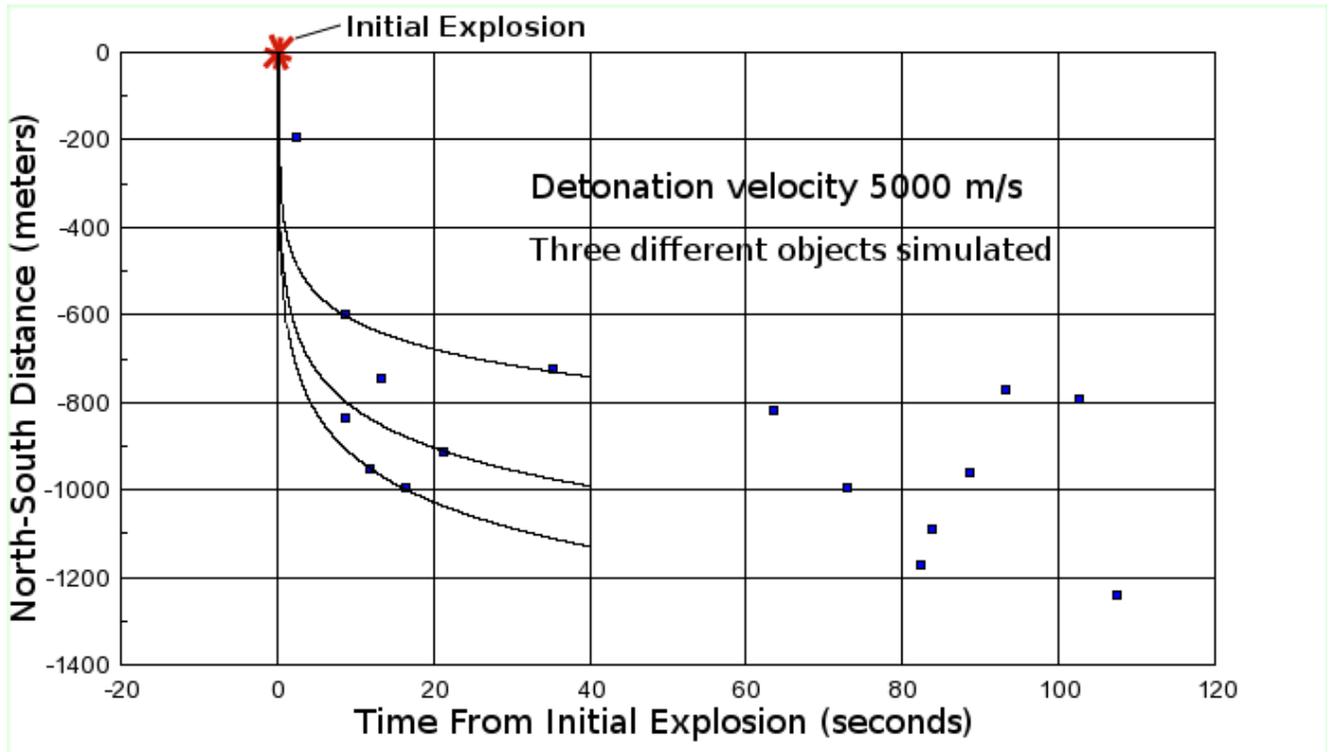
**Figure 4:** Three ballistics curves fit to north-south position vs. time from the Islip and White Plains radar sites. This plot only shows the north-south distances and speeds. Flight 800 was heading ENE at 385 knots. The small blue squares are a composite of Islip and White Plains FAA radar returns.

aerodynamic properties. Three ballistics curves fit the data well, each with exit velocities greater than Mach 4 (four times the speed of sound). Curves with exit velocities below Mach 4 and with low drag forces relative to their mass would not decelerate fast enough to fit the data. Curves with high drag forces relative to their mass and with exit velocities less than Mach 4 would not reach the earliest and southern-most debris recorded by radar.
